EVALUATION OF THE BRAZILIAN RUN-FLAT  
TIRE

Nevada Automotive Test Center

Army Tank-Automotive Command

Final Report  
NATC Project 20-1-872  
Technical Report No. 11923  
Contract DAAE07-74-C-0109

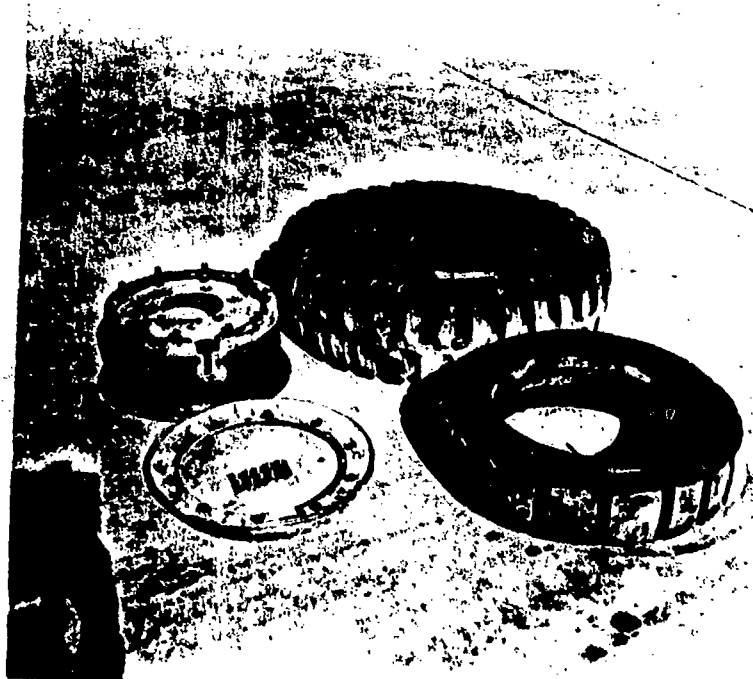
Photograph #201872-1

Component parts of the low vulnerability  
tire and rim assembly

Four mounted and four unmounted 8.00-16 military non-directional mud and snow t/y. bias ply tires, manufactured by Firestone, with special inner liners and a solid rubber insert were received for run-flat test. The mounted tires were on two piece tubeless rims and both tires and rims were manufactured in Brazil.

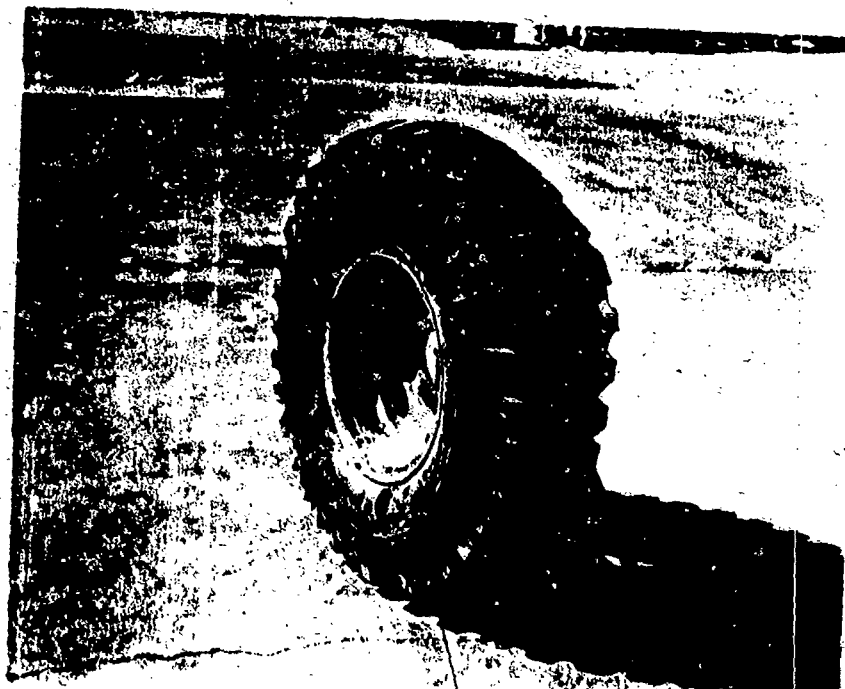
Photograph #201872-5

Tire A-1  
Separation failure without air loss

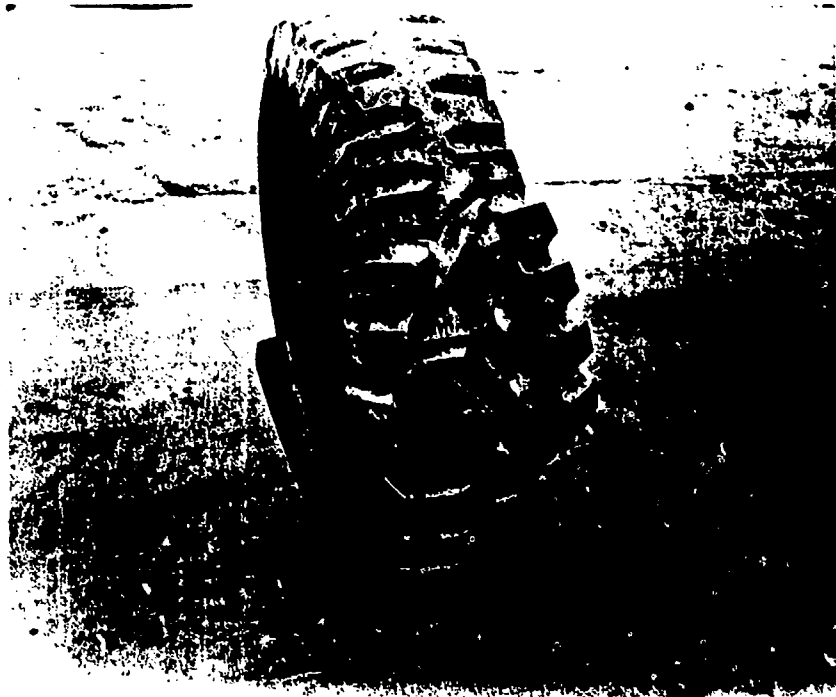
Photograph #201872-6

Tire A-4  
Separation failure with air loss

<u>Tire Code/ Serial No.</u>	<u>Wheel Pos.</u>	<u>Total Test Miles</u>	<u>Reason For Removal</u>
A-4 E15U003909	RR	2883.6	Sudden air loss due to massive rupture across tread. Failure may have been induced by rock impact on cross-country or secondary section of test course. Failure appears to have started 1 1/2 inches from outside sidewall in tread area under a tread lug. A slight brownish discoloration is evident at the root of the "V" shaped tear which extends across the tread to the inside shoulder. Approximate temperatures at time of failure were 107°F. ambient and 158°F. surface. Replaced with tire A-5, S/N E15U004953.
